# ANNABELLA Hull Analysis

### Annabella: Hull Analysis of a North American Coasting Vessel

#### An Institute of Maritime History Research Project

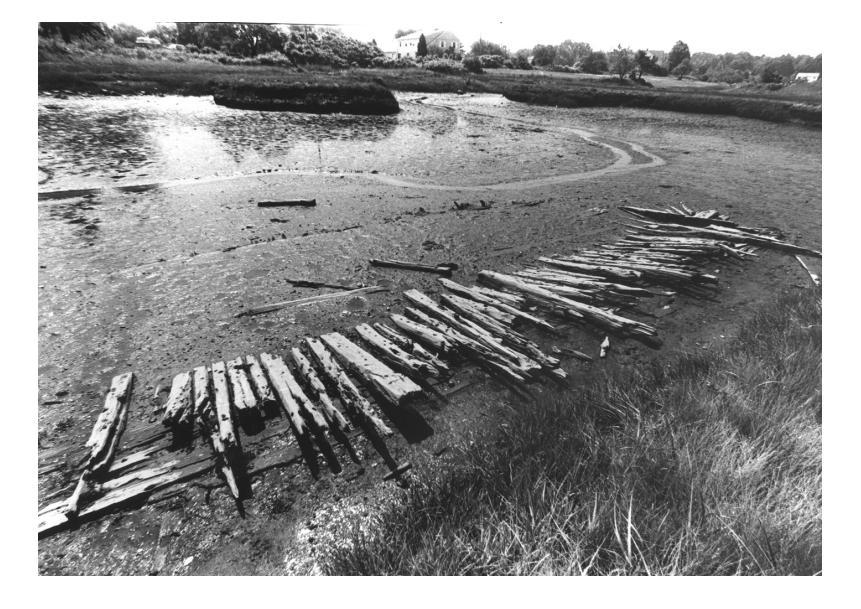
Figure 4. The derelict vessel prior to the excavation. To the right is the bow of the vessel. (Photograph by Patrick Grace)

Located in Cape Neddick, Maine, the remains of *Annabella* came to the attention of the Institute of Maritime History in 1993. The hull of *Annabella* lay partially exposed during low tide, lying on its port side; as a result, the starboard frames and planking had eroded noticeably, primarily as a result of the constant tidal changes in the river (FIG. 4). The port side of the vessel lay buried beneath the sediment, protecting the wood from decay and erosion. The visible features of the hull and its location in the shallow tidal flat suggested that it was a derelict vessel, laid up against the

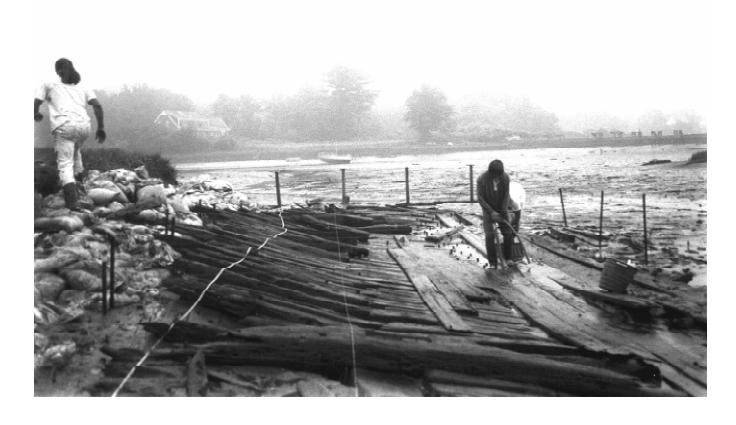
Figure 7. The excavated remains of *Annabella* seen at low tide (facing the stern). Sediment excavated from the hull was put in semi-permeable sandbags and placed along the starboard side of the vessel remains.

The sediment overlying the site was cleared from each unit with shovels and trowels and placed into semi-permeable sandbags (FIG. 7). Placement of the sediment into the sandbags prevented the sediment from being redeposited elsewhere in the river, but did not allow the excavators to screen this material for smaller artifacts. We initially used shovels to remove the mud in approximately 1-inch layers from each unit. Layers of sediment that had accumulated shortly after the vessel's abandonment, trowels and wooden tools were used to scrape through these deposits, revealing *in situ* artifacts. The location of artifacts were mapped from the grid coordinates and each find was

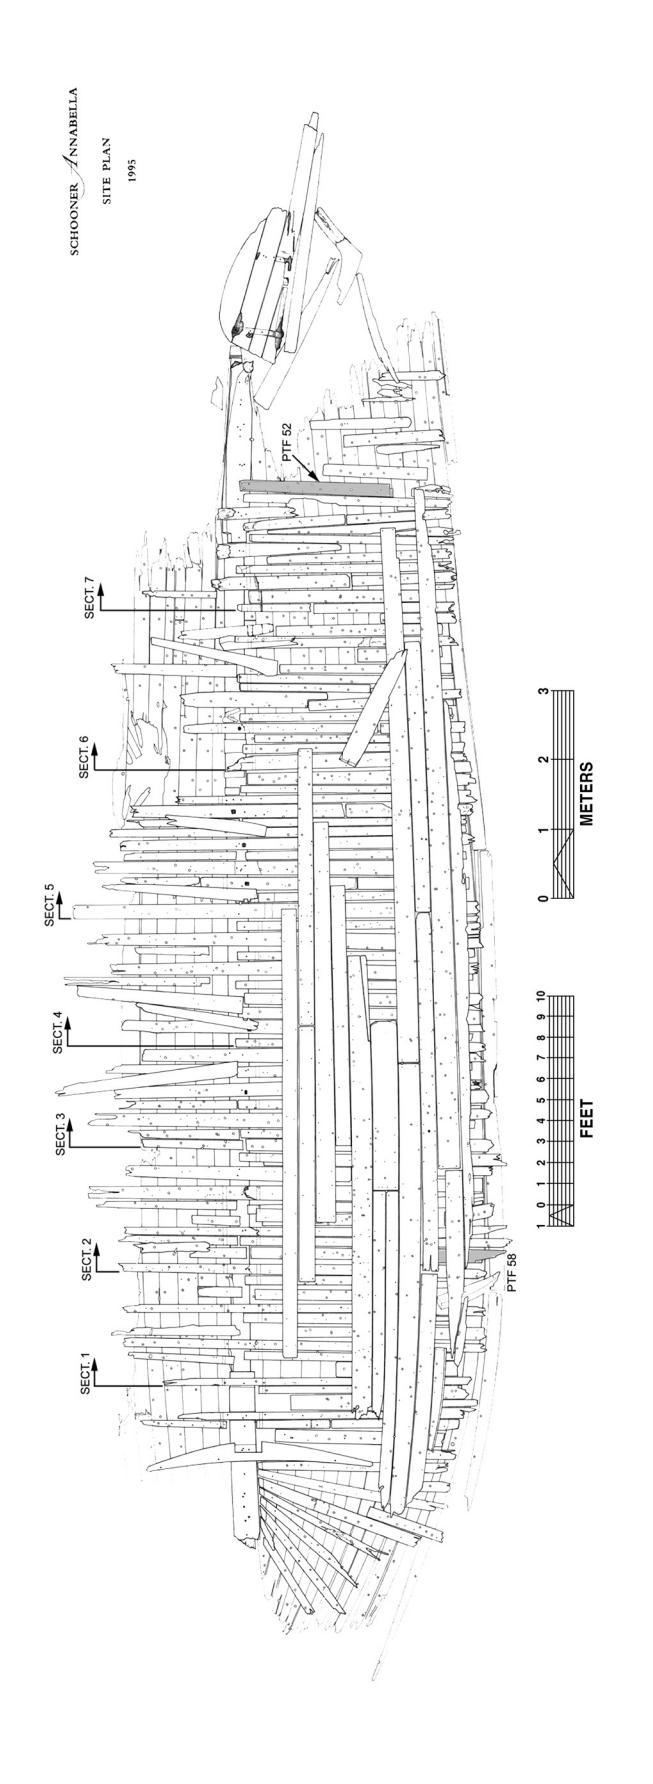
Figure 5. Site plan of Annabella.

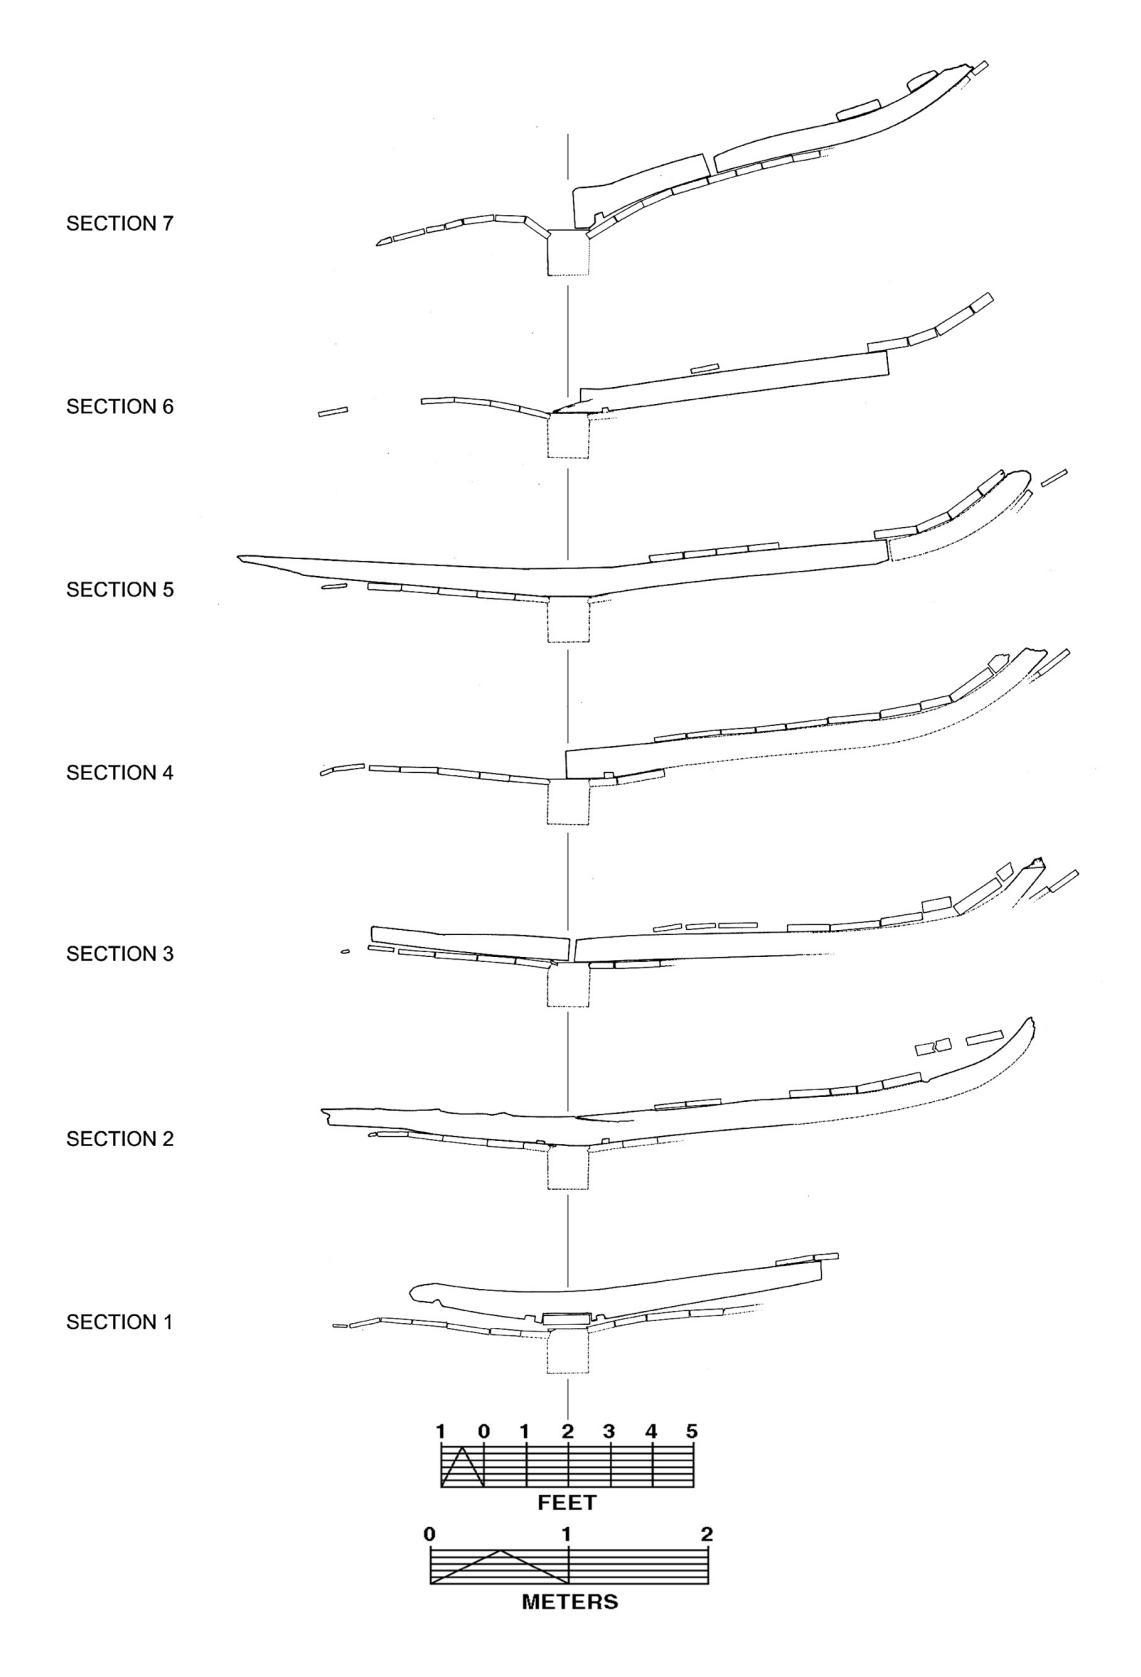
Figure 6. Hull sections were recorded at approximately 3-m intervals along the length of the hull. The locations of the sections are illustrated in Figure 5.

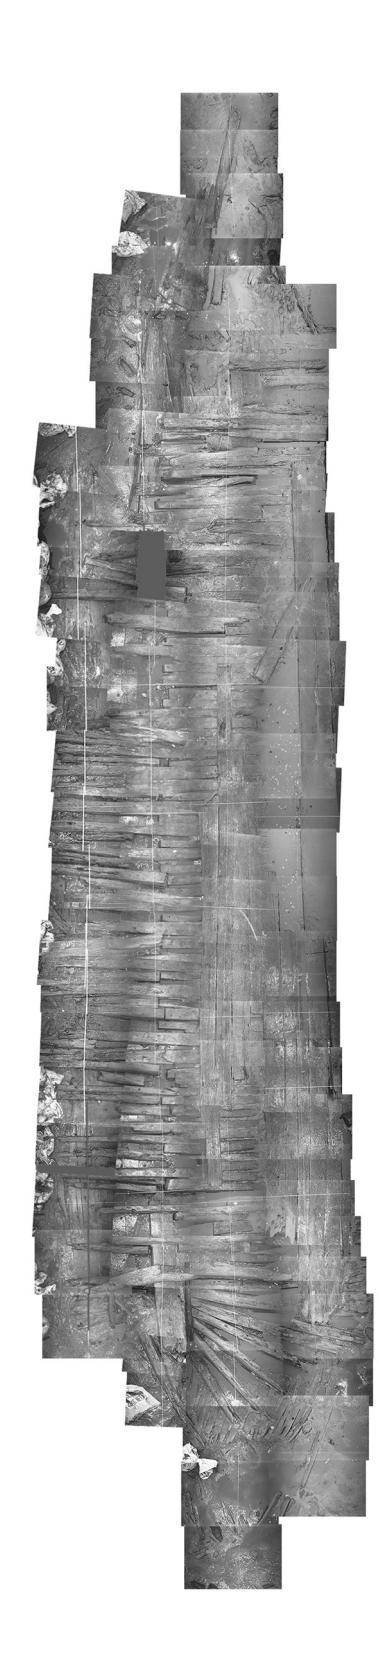
Figure 8. Photomosaic of the hull remains.

The vessel that we examined in 1995 experienced over a century of deterioration, and the timbers bore evidence of decay and damage. Each day, when water receded during low tides, leaving the schooner high and dry in the flats, a considerable amount of pressure was placed upon the hull. Annabella's upperworks had long ago disappeared, and only on the port side was the hull preserved to the turn of the bilge. On the starboard side of the hull, planking had fallen from the frames, distorting the shape of the lower portion of the hull. Floor timbers supporting the starboard side had also cracked amidships, and that entire side of the vessel had collapsed. Much of the bow structure was preserved, including cant frames, apron, and what appears to be a chock or the heel of the stem; in the stern, portions of the vessel's stern knee and rudder also survived.

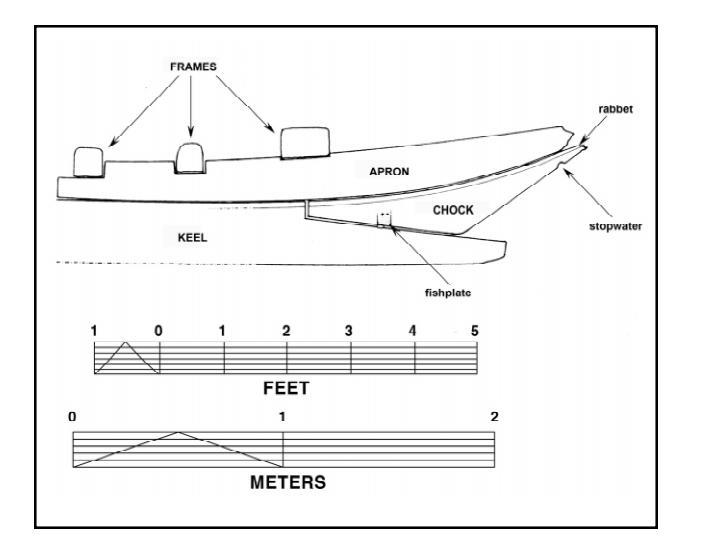
Figure 9. Profile of the keel, chock, and apron.

The stem of the vessel was not found during the excavation, but the apron and a curious chock do exist (FIG. 9). These timbers are of white oak and were fastened to the keel by iron through-bolts. The apron has a maximum length of 2.45 m and is 22 cm molded and 38 cm sided. Three notches are cut into the top of the timber for the placement of the forwardmost floor

timbers. The notch at the extreme after portion of the timber is 10 cm deep, the middle notch 6 cm, and the forward notch 2 cm. The lower edges or undersides of the timber are beveled to receive the hood ends of the garboards and first strakes.

Chamfered rabbets are also cut along the upper edges of the chock for fitting the garboards. The chock has a maximum length of 1.35 m, is 27 cm sided, and has a maximum molded dimension of 24 cm. A semicircular concavity located at the forward upper edge of the timber is likely a stopwater impression. In addition, nail holes and a shallow mortise located at the lower edge of the chock may be the remnants of a fish plate, although there are no corresponding mortises or fasteners on the keel.

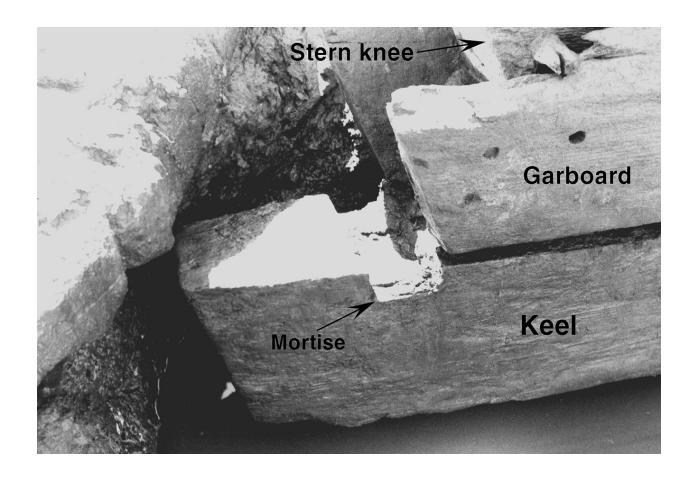
Figure 10. The stern assembly showing the stern knee, garboards, and keel. Note the mortise in the keel for the placement of the sternpost.

The sternpost was not located during the excavation, but the stern knee and complete rudder were exposed at the stern of the schooner. The stern knee is a naturally curving timber of white oak (FIG. 10), and its dimensions vary considerably. It has a maximum sided dimension of 37 cm and tapers to 23 cm at the throat. The upper portion of the stern knee is broken off, but its maximum preserved height is 63 cm, and the rake of the timber is approximately 20 degrees from vertical. The molded dimension of the stern knee is approximately 20 cm. A pair of notches are cut into the sides of the stern knee for the placement of half frames. The notches are 16 cm wide (parallel to the keel); the notch in the starboard side of the timber, however, is 10 cm deep, while the port side notch is 5 cm deep. The garboards were fastened to the stern knee with iron nails and treenails, and the stern knee was fastened to the keel with 15 iron through bolts.

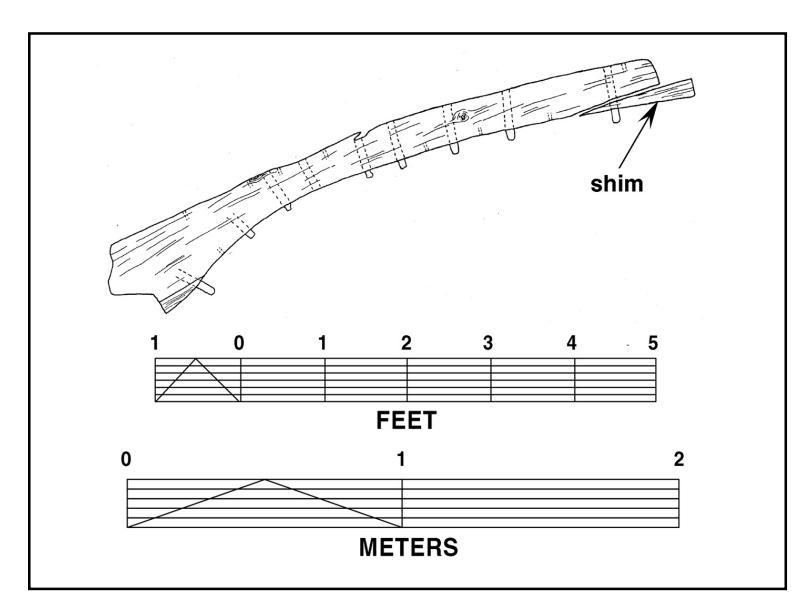
Figure 12. Stern hull frame PTF 52 with a shim treenailed to its outboard face.

floor timbers to fill in any gaps. In addition, shims were used to fill in areas between the futtocks and the hull planking (FIG. 12). This type of heavy construction would have been necessary to carry bulky cargoes such as cordwood and brick. None of the futtocks are fastened laterally to adjacent frames but are generally attached to the hull planking by treenails. Though most of the treenail holes extend through the planking and frames, there are a number of wedged treenails in blind holes (PTF 58, for example [see FIG. 11]).

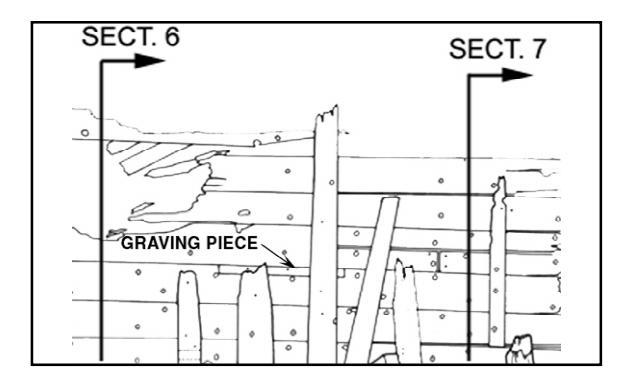
Figure 13. Detail of site plan showing the location of one of many graving pieces in the hull planking.

The planking is of red oak, measures 4 cm in thickness, and averages 23 cm in width. The quarter-sawn planks are fastened to the frames almost exclusively with treenails, though graving pieces located forward of FLR 23 (FIG. 13), have been fastened with iron nails. In addition to being treenailed, the hooding ends of the first strakes at the bow of the vessel are fastened

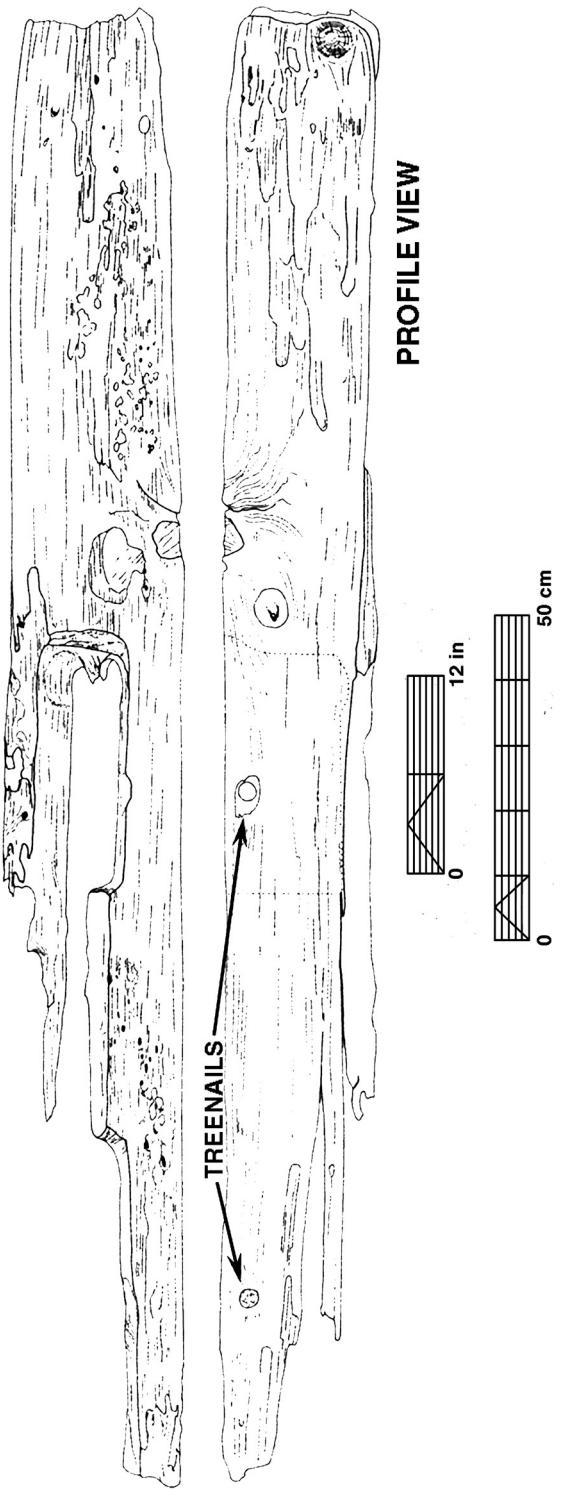
**PLAN VIEW**

mast step for a ship (FIG. 15). The timber is extremely eroded and no surface detail is discernable, and the timber's distance from the excavation site prevents a firm association with *Annabella*. Moreover, ship timbers are widely scattered throughout the Cape Neddick tidal flats; the timber may derive from one of many other shipwrecks in the area. It is, however, of the same type of wood as the frames of *Annabella* (*Quercus* sp.). Its identification as a ship timber can be further

supported by the fact that treenails are visible around the rectangular cut in the center of the timber. At the base of the rectangular cut is a circular depression that may represent wear from repeatedly stepping a mast. The timber is 2.25 m in length, and it has a maximum sided dimension of 26.9 cm and a molded dimension of 23.5 cm. upper pintle, the lower pintle has an iron strap extending across the face of the rudder pieces. Both of the iron straps were fastened to the rudder by iron nails.

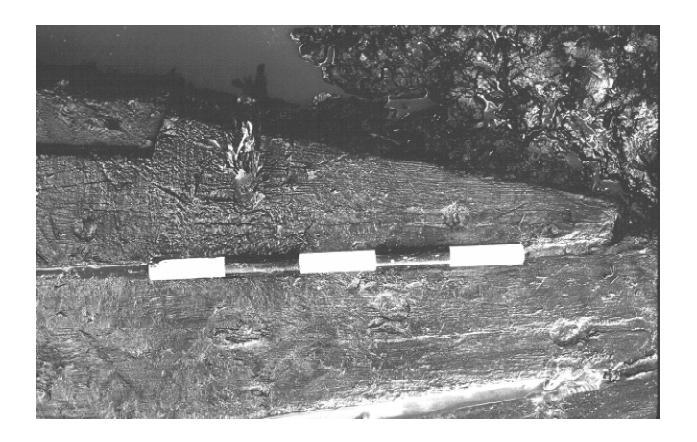
Figure 14. Detail of port garboard and joggled end of first strake at the bow. The scale is in 10 cm increments.

with a single iron nail and are joggled to fit the garboard strakes (FIG. 14). The garboard strakes are 25 cm wide and 6 cm thick amidships, but they taper in the bow to a width of 5 cm and a thickness of 3 cm. In the stern the garboards are treenailed and nailed to the stern knee in an almost vertical position.

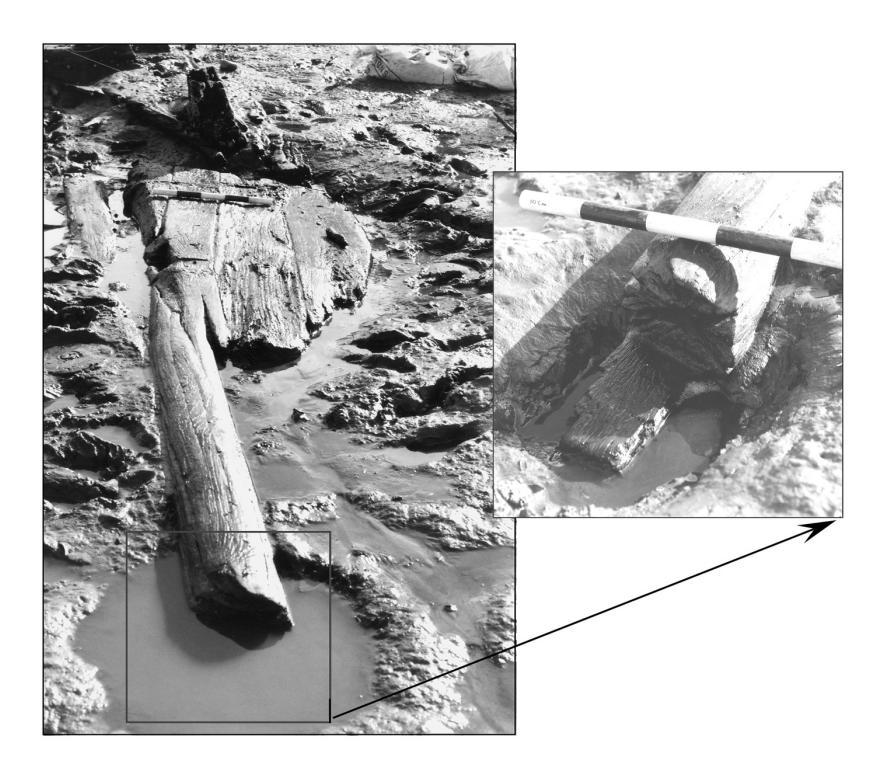
Figure 16. Rudder with detail of tiller scarf shown in inset.

Chamfered notches have been cut into the forward edge of the main piece for the fitting of two pintles. The upper pintle of the rudder is cylindrical, 12 cm in length and 5 cm in diameter. The iron of the strap has deteriorated considerably, though heavy iron staining and impressions indicate the original extent of the fitting. The lower pintle is concreted, obscuring its details and dimensions. Like the

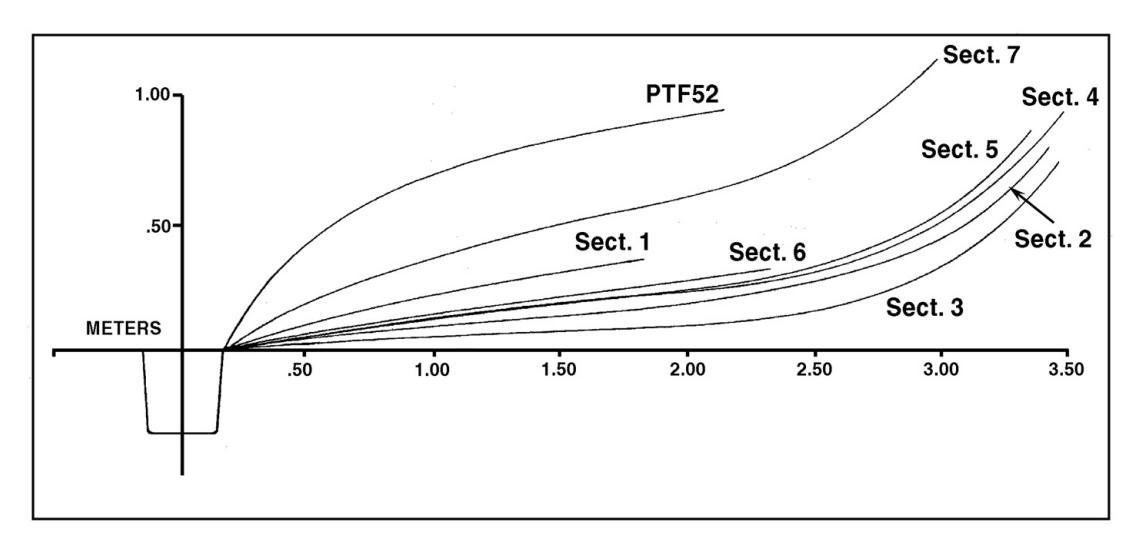
Figure 21. Section lines of the preserved remains of Annabella.

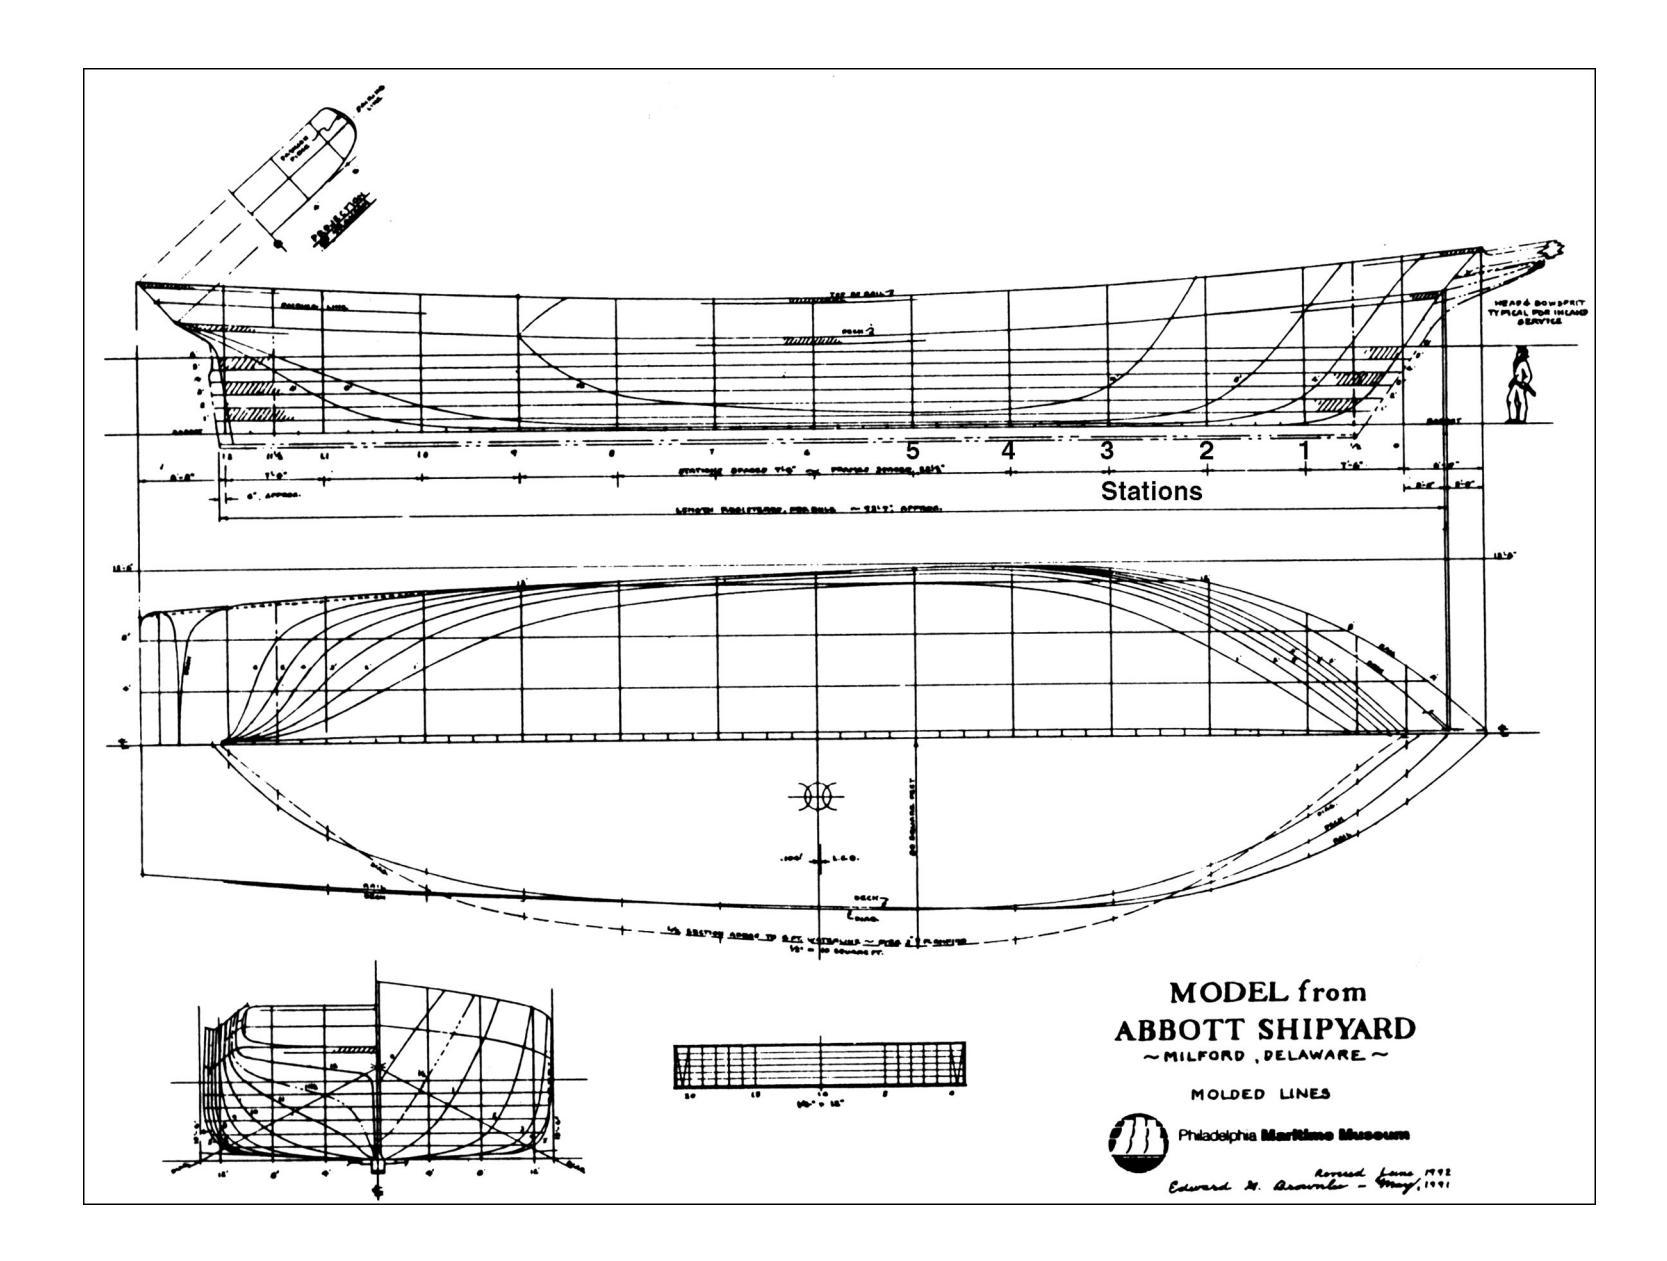
Figure 22. Lines of a Milford, Delaware vessel. (Courtesy Independence Seaport Museum, Philadelphia, PA)

sel type has also been documented by Brownlee (1994) and Macdonald (1990). Lines derived from a half-model (19th century) from the Abbot Shipyard in Milford, Delaware (FIG. 22), cannot be associated with any vessel from the Delaware region (Brownlee 1994: 120). Based on the dimensions and form of the ship, it is likely that this type of vessel was a two- or three-masted schooner designed to navigate the shallow tidal tributaries of the Delaware and Chesapeake Bays. Similar to *Annabella*, this type of vessel had a nearly flat bottom and a very shallow hull.

The 19th-century half-model from Milford, Delaware (FIG. 22), has been a useful tool in illustrating some aspects of the construction techniques that were used for designing and building vessels from the Delaware Bay region. On the back of the Abbot shipyard model, three vertical frame lines are drawn in pencil. A mark has been made at station 4 and at 22 1/2 and 44 inches aft of station 4. Station 4 marks the point of greatest breadth or amidships, and corresponds to the master frame location. The master frame location on the model is remarkably similar to the location of the master frames of Annabella. In addition, two marks at Station 1, and 22 1/2 inches forward of Station 1, are indicative of a frame spacing of 20-22 1/2 inches. This method of design and layout of frames was likely a common technique and Annabella, conceivably, underwent similar pre-construction design through use of a half model. These dimensional attributes adhere closely to ASA shipbuilding standards; Annabella's frame spacing, however, is a mere 15.7 inches forward of the master frame and 7.8 inches aft of the master frame. Contemporary practice suggested a frame spacing of 27 inches, which was likely compatible with the locations of deck fixtures (Brownlee 1994: 135).

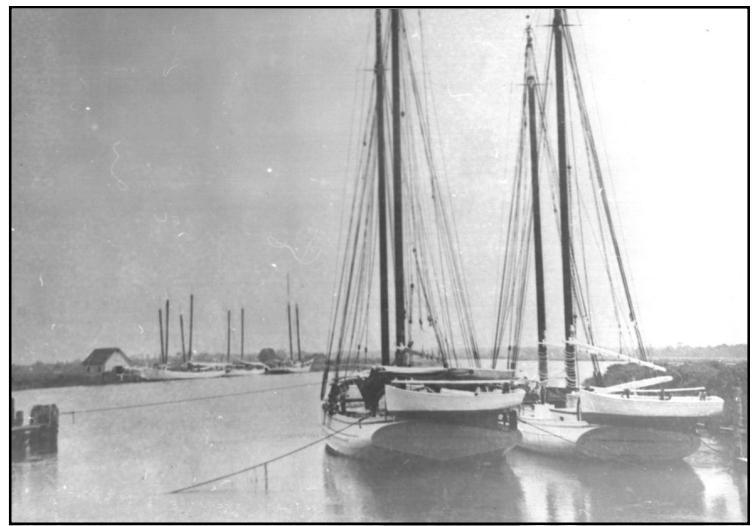
Figure 24. The elliptical stern was a common characteristic of southern New Jersey schooners. (Courtesy Cumberland County Historical Society, Greenwich, NJ)

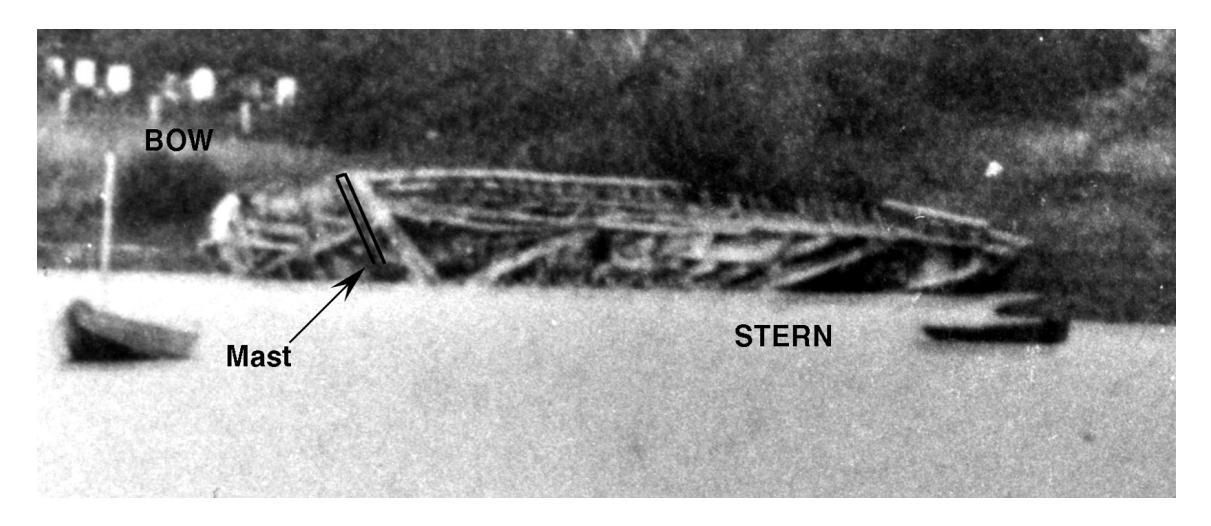
Figure 26. Annabella, as seen shortly after its abandonment in 1885. The poor resolution of the photograph results from its enlargement from a panoramic photograph taken of the Cape Neddick River circa 1890. (Courtesy Old York Historical Society, York, ME.)

Figure 26 shows an enlarged image of *Annabella* taken from a panoramic photograph of the Cape Neddick River around 1890. The condition of the ship is clearly discernable in the picture, which was evidently taken shortly after the abandonment of the vessel. Top timbers are visible along the starboard side of the vessel, as well as decking, deck beams, and the holds of the schooner. A mast step may have been located near the aft end of the apron, as the foremast is visible in the bow. Computer enhancement of the photograph was attempted but was unsuccessful because the resolution of the original photograph is too poor. A maritime painting of the schooner *Thomas G. Smith* is also useful in interpreting parts of the super-structure of *Annabella* that are no longer extant (i.e.,
